Proper Functioning Condition
And
Amendment 6 Assessments and Ratings
For
Templeton Allotment
Summer 2010

Prepared by: Lisa Sims, Inyo National Forest Aquatic Biologist

March 2011

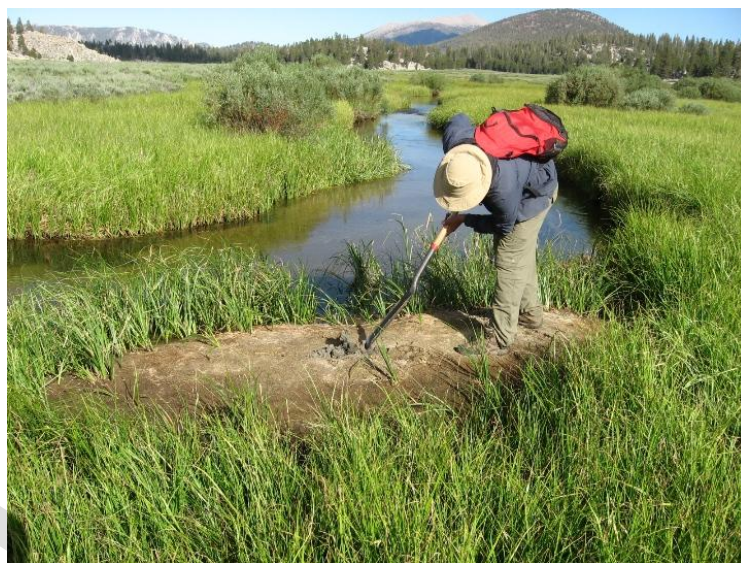
Photo above: Digging through a recent sediment deposit along Ramshaw Meadow.

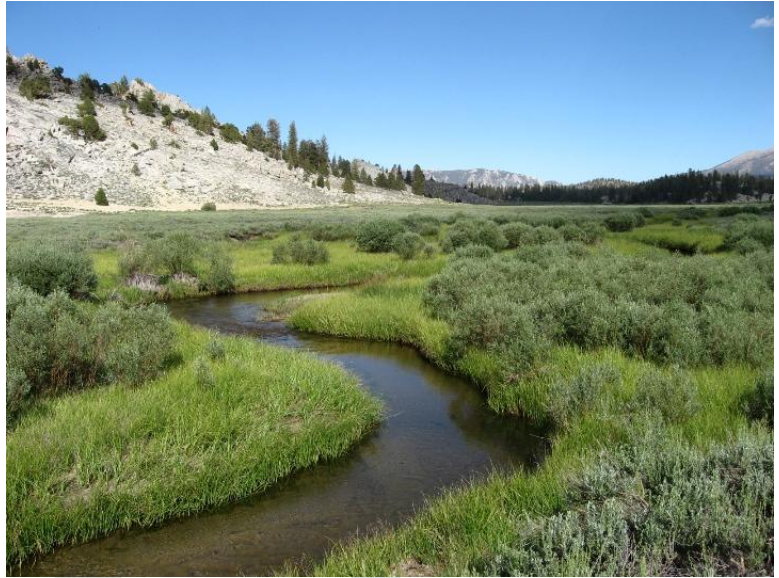
Photo at right: An example of the stream channel throughout the Ramshaw and Templeton meadows that exhibits vigorous riparian vegetation, willow establishment, narrowing of the channel, but the sediment load dominates the substrate of the stream bottom. Compared to the stratigraphy of the substrate revealed in the banks, the sandy bottom is not out of character for the potential of the area.

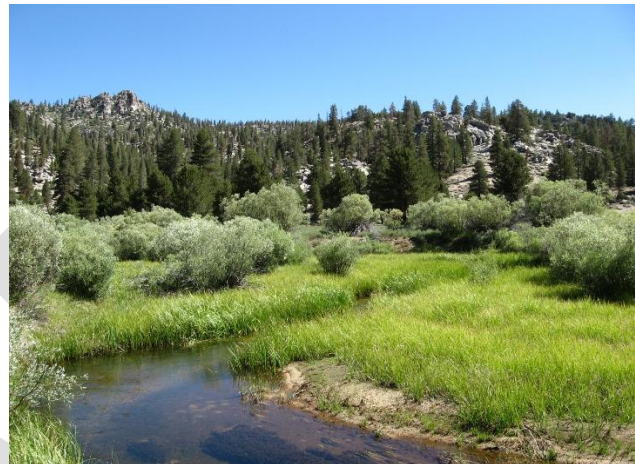
Photo above: Typical riparian condition within the upper reach of Ramshaw Meadow. Recent deposition is evident on inside bend.

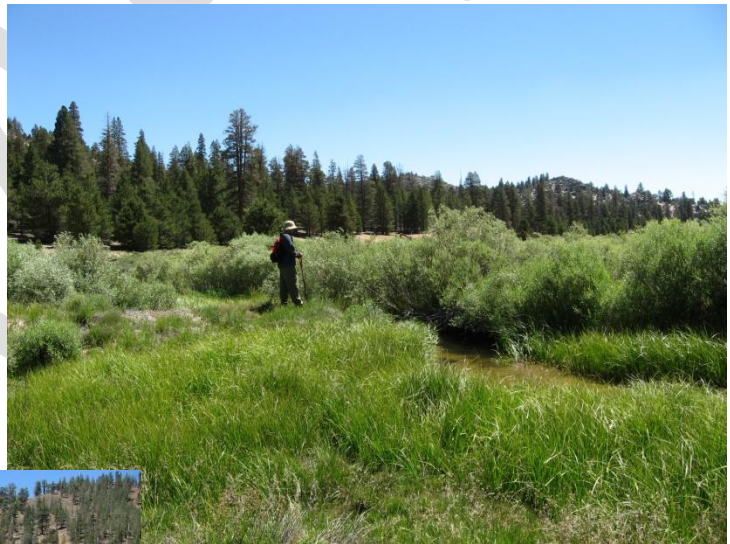
Photo Right: Standing on top of breached beaver dam. Vegetation was vigorous above and below old dam.

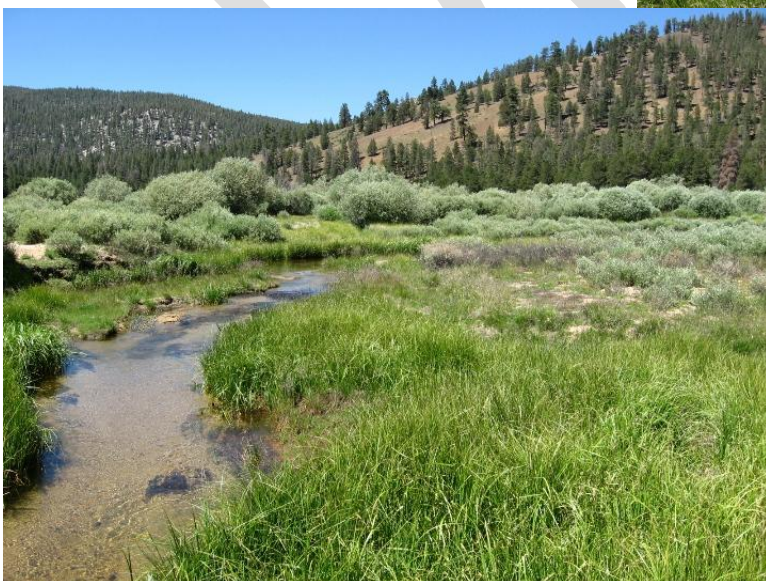
Photo to Left: Ramshaw Meadow: Area of the stream just below the beaver dam. PFC gives a “No” rating if beaver dams are not stable AND active. The riparian area below the dam is recovering well and majority of the area above and below the dam is stable and responding well to the disturbance.

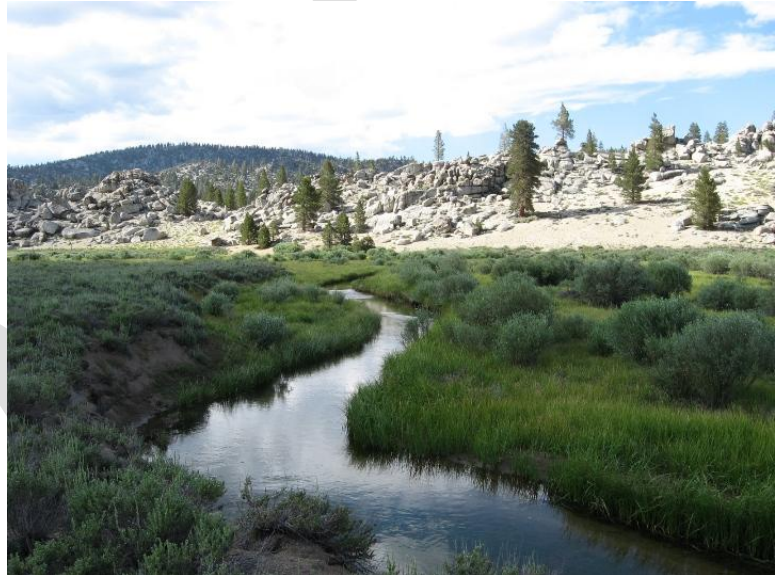
The old beaver dam was stable and well vegetated. Lateral movement of the stream was active in 2010 due to high flow run-off with a high amount of bed-load (sand) in the floodplain which was trapped by the established vegetation from previous years.

Photo above: Typical example of the condition of the channel as it flows through middle Ramshaw Meadow.

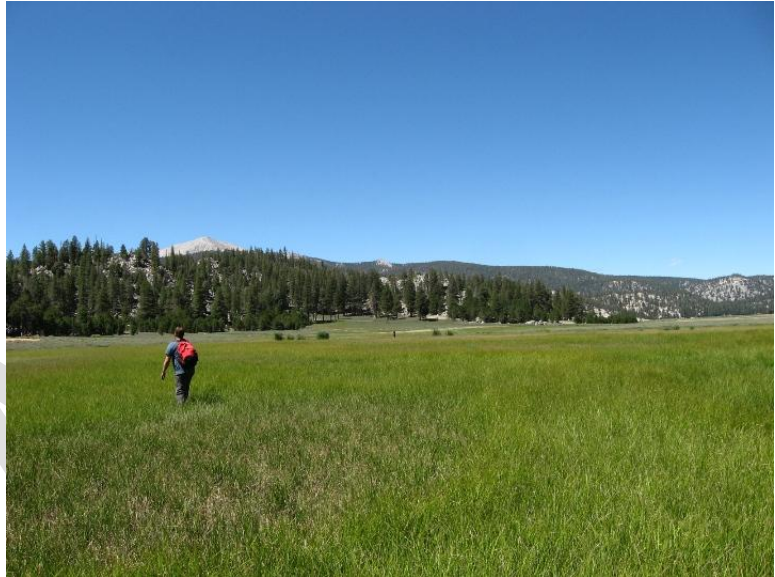
Photo above: Overview of the middle section of NE Ramshaw Stringer.

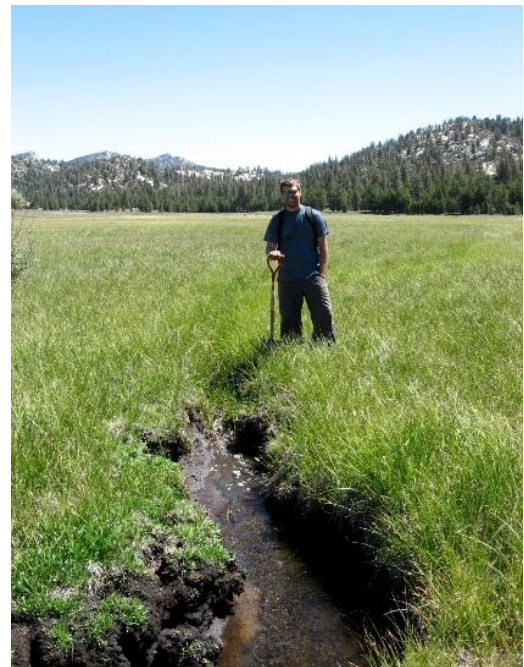
Photo above: The upper extent of recent headcut migration within NE Ramshaw Stringer Meadow.

Noted at the lower end of the Key Area is a headcut approximately one foot in height which had moved upstream about 15 feet in the 2010 high-flow event (photo, above). This headcut occurred through what would be considered as a highly stable vegetation community, however, there was extensive rodent activity observed along the margin of the headcut where it originated. This headcut essentially puts the entire meadow at risk of downcutting and lowering the base level of the meadow. The headcut should be treated or at least fenced off if cattle are to resume grazing. Another extensive headcut occurs up a side channel (photo,below), again threatening the meadow function if it is able to continue migrating upward.

Proper Functioning Condition: One PFC reach was rated through this meadow. All parameters were rated as “yes”, except for the question, “System is vertically stable”. This is due to the two headcuts observed and illustrated above.

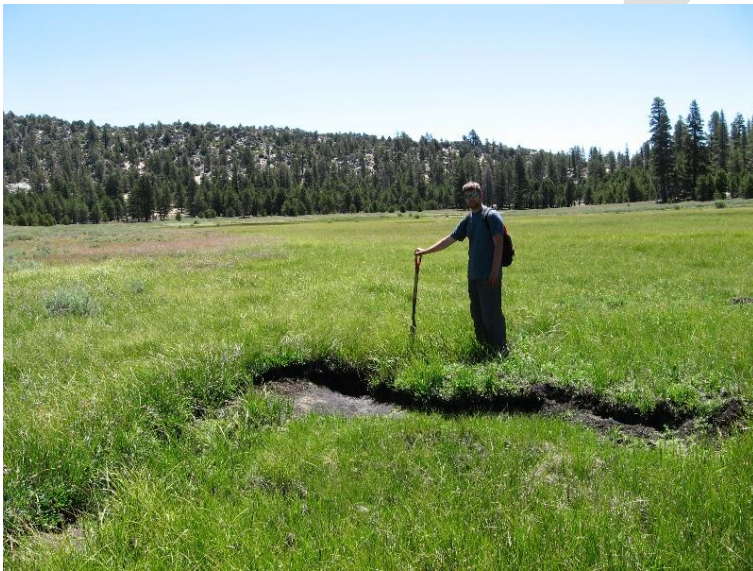
Photo above: Wide headcut that is migrating into the side meadow within NE Ramshaw Meadow.

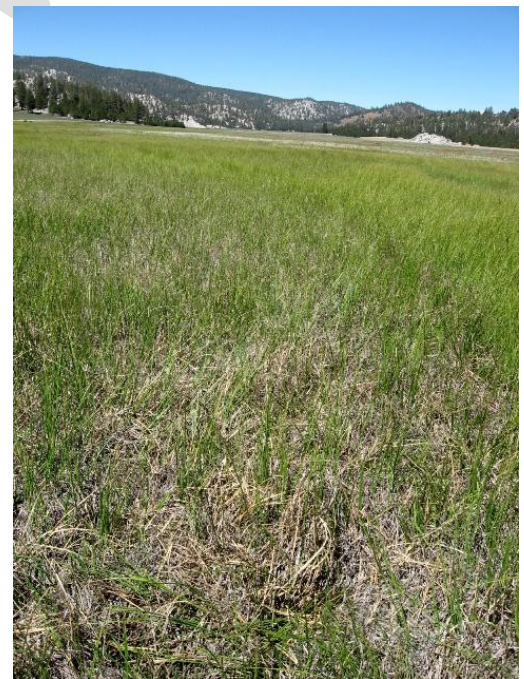
This meadow has been rested from grazing for approximately 20 years. An enclosure was built in the late 1980's to rest the area from the impacts of grazing. Heavy thatch has built up in the *Carex* dominated portions of the meadow, causing a decrease in vigor and plant re-establishment within the meadow.

Photo above: Thatch build-up within NE Ramshaw Meadow.

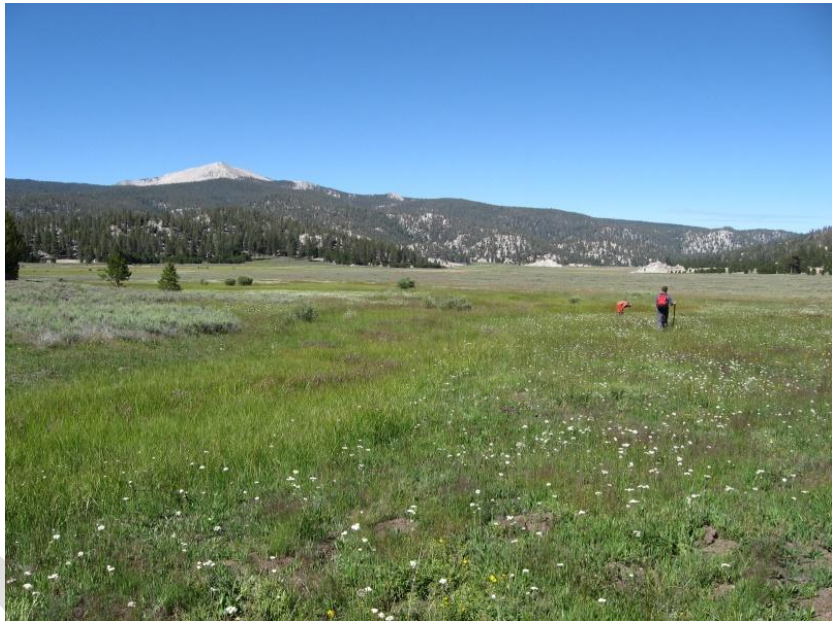
Photo above: Overview of NE Ramshaw Meadow taken from the upper end of the meadow towards the lower end and the confluence with the South Fork Kern River.

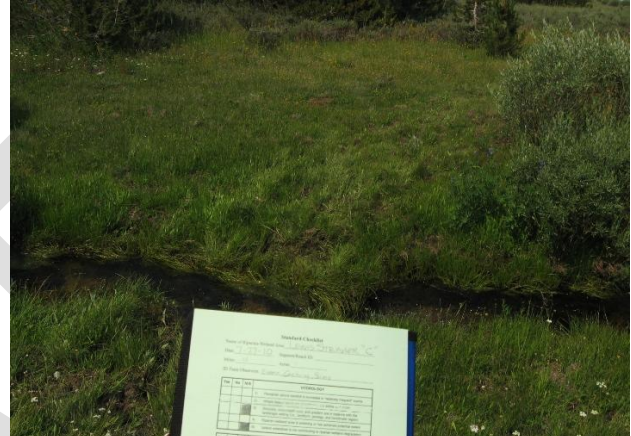
Photo above: Meadow condition within the area of Lewis Stringer.

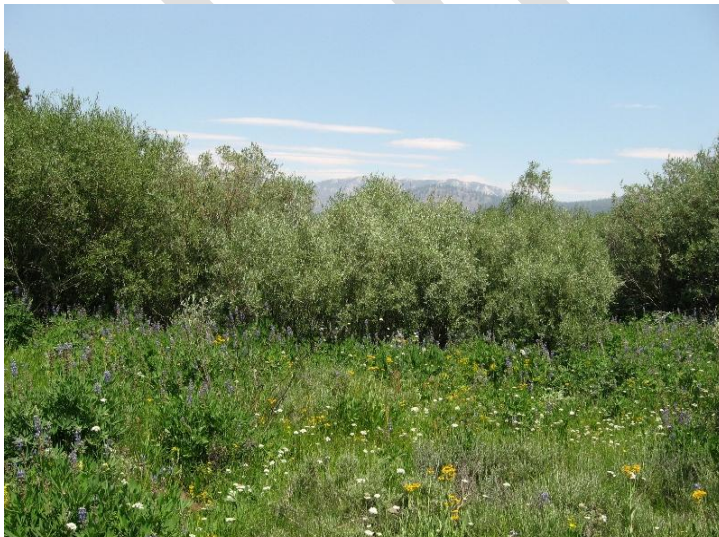
Photo above: Lewis Stringer within the upper reach.

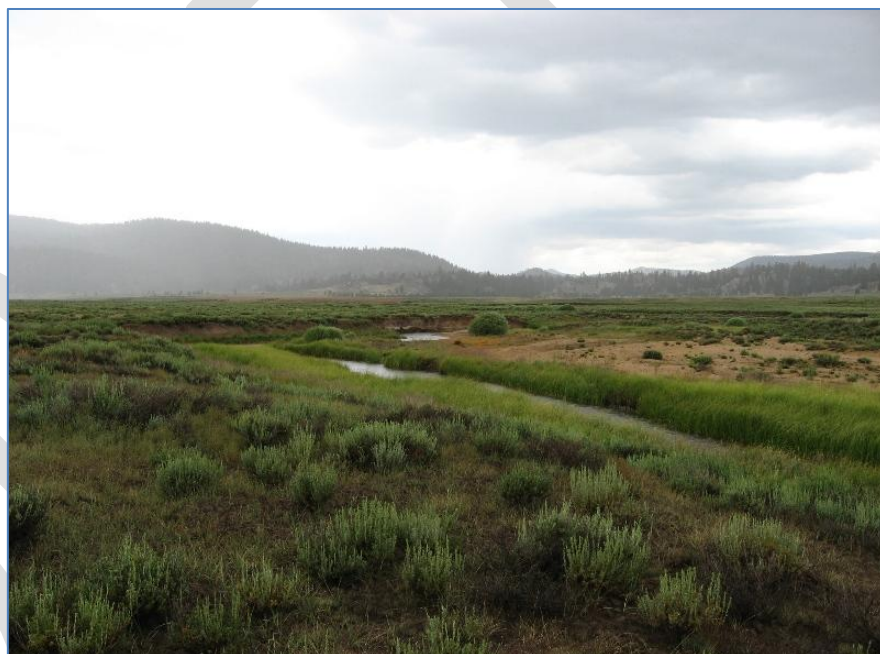
Photo above: Overview of Templeton Meadow, showing developing floodplain and the characteristic high, alluvial banks with typical upland vegetation.

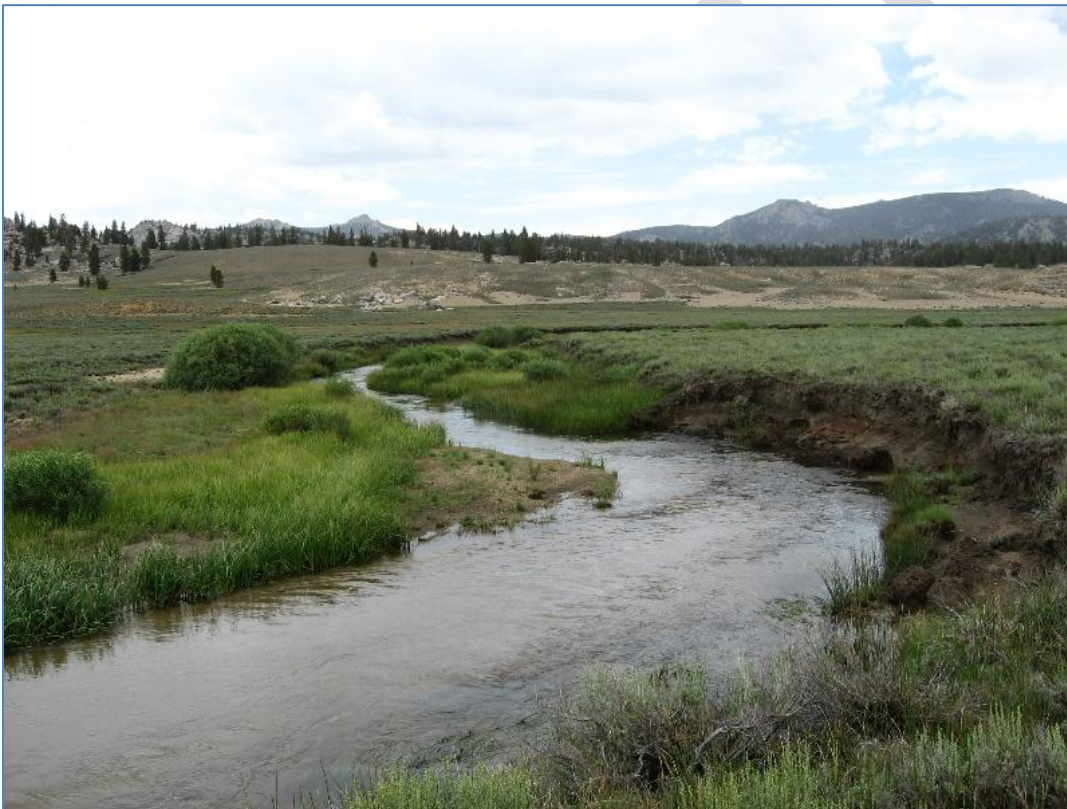
Photo above: An example of the dynamic nature of Templeton Meadow through Reach B. Displayed here are examples of bank-building, lateral movement into the alluvial terrace, establishment of late seral vegetation and deposition on new floodplains.

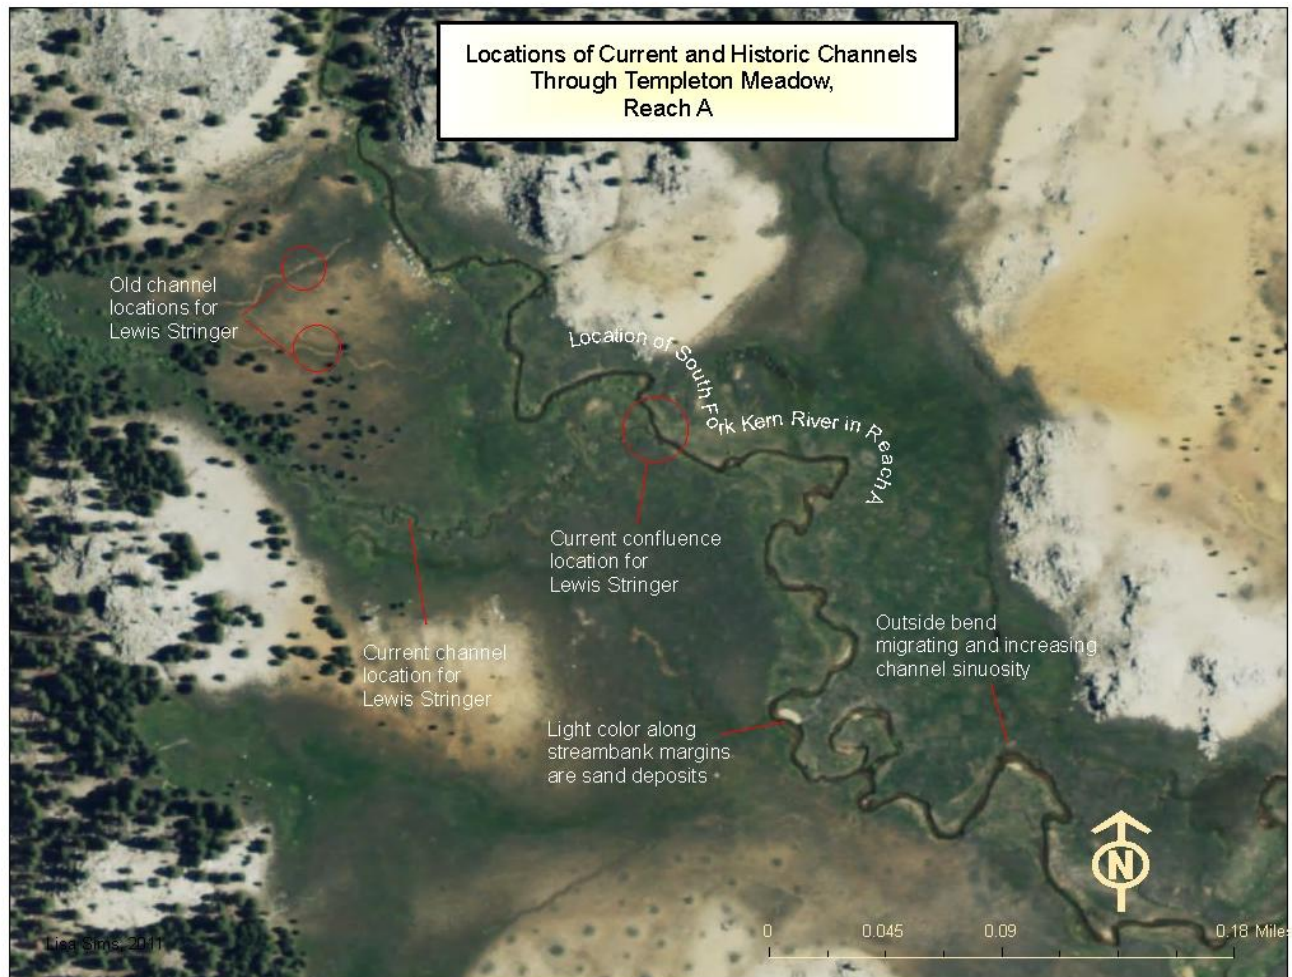
Above: Note the distinct difference of the channel between the condition of Reach A and Reach B (figure, below). This reach of the river is much less dynamic as evidenced by the presence of more green vegetation along the streambanks, and less sandy areas along the banks, which is very obvious in Reach B.

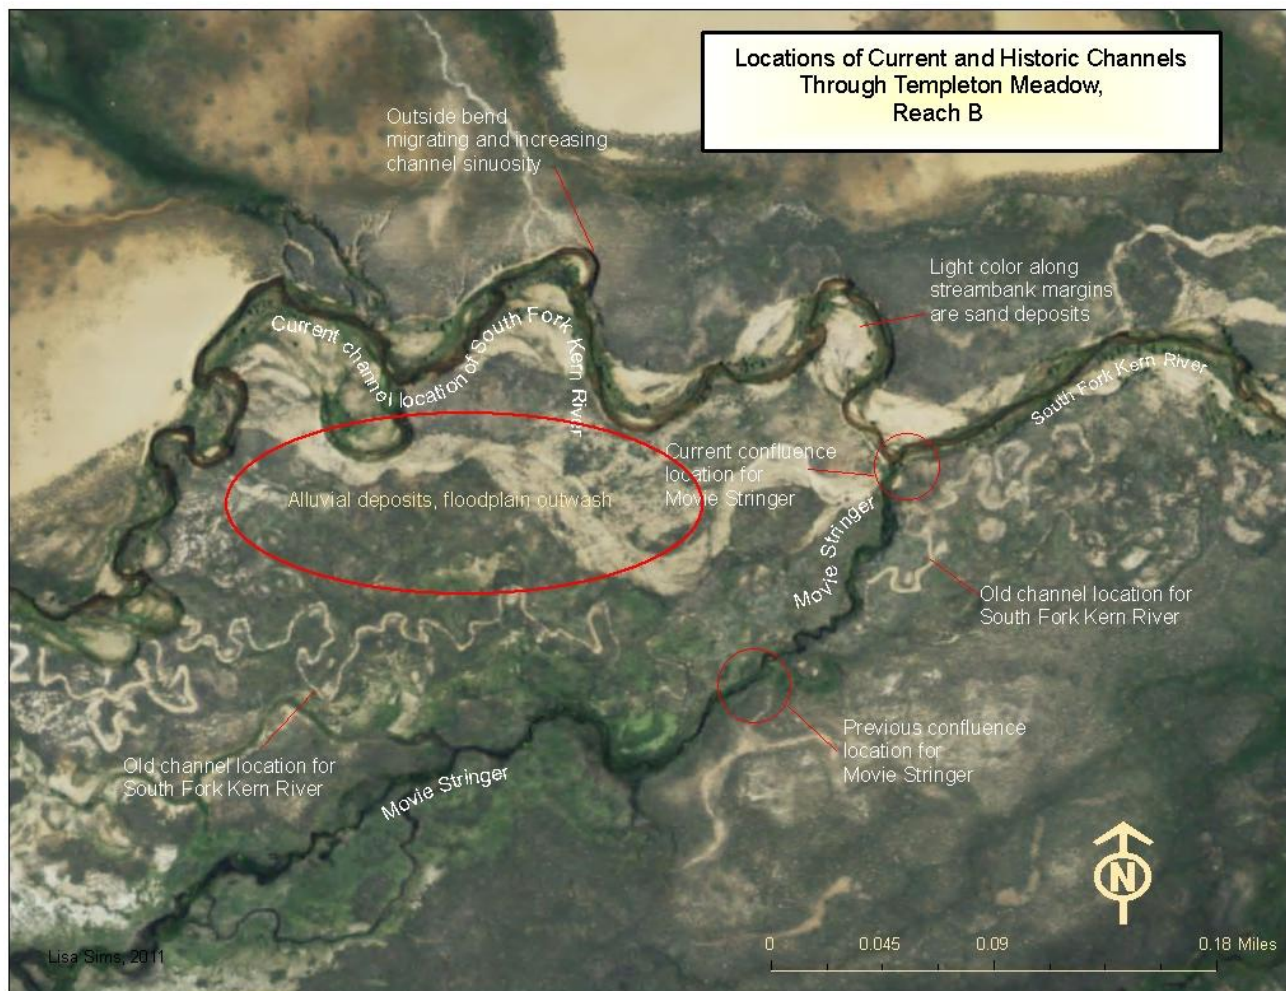
deposits on top of the old terraces that the river has had to cut through”. Vegetatively, there is a diverse age-class and composition of riparian vegetation, but there is not adequate vegetation cover to protect bank, especially on the tops of the sandy alluvial terraces, where riparian-type of vegetation would not be expected. Because the lateral movement of the stream continues through the alluvium every year, vegetation does not have an opportunity to establish within the outside bends. However, there is very good recruitment of riparian vegetation on the inside bends of the river, which increases floodplain area. This dynamic is a natural process of streams that leads to increased floodplain area, increased sinuosity, and decreased channel gradient which buffers the meadow against the scouring effects of high flows, or flood events. As water spreads out over the floodplain, it slows down and suspended sediment drops out and is trapped by vegetation. The deposition of sediment onto the flood plain is what builds meadows and brings new nutrients to meadow vegetation. For the PFC Assessment, it was determined that the stream is not in balance with the water and sediment being supplied by the watershed due to the abundant amount of sand that is distributed along the developing floodplains. For this reason and others mentioned above, this Reach of stream was rated as FAR with an upward trend.

Above: An example of the dynamic nature of the South Fork Kern River through Templeton Meadow. This is at the same scale as the previous aerial photo. This exhibits the area of Reach B, showing the different locations of the channel, including the different location of the confluence with Movie Stringer. Note that compared to the photo above, and to the location of the old channel, the current location of the channel is much less sinuous. The channel is in the process of increasing sinuosity as evidenced by the outside bends.

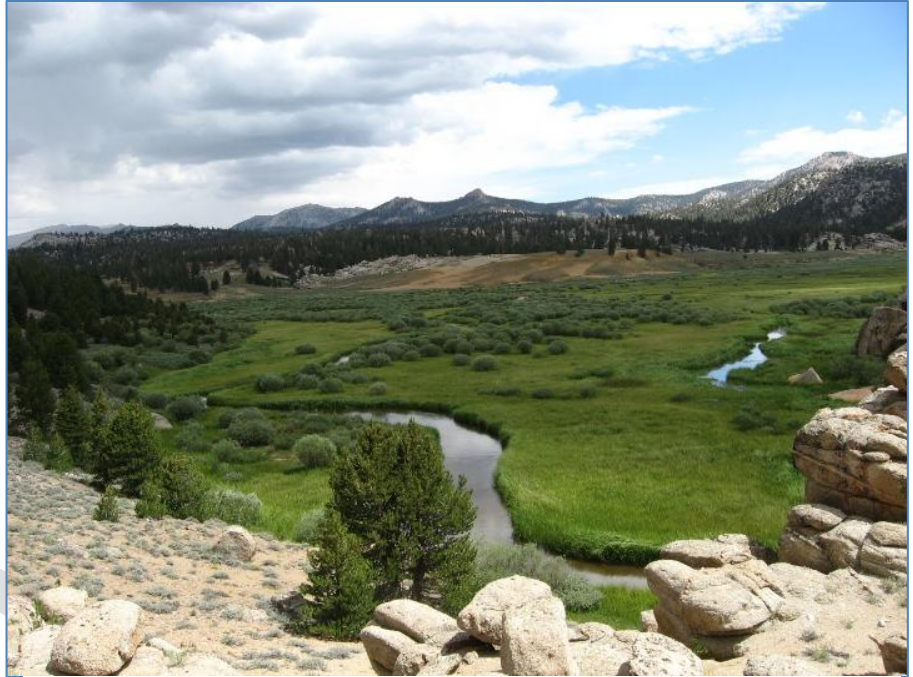
Reach C of Templeton Meadow includes the area 150 yards downstream of the confluence with Mulkey Creek to the top of the Templeton Fish Barrier. Since the construction of the barrier in the 1970's, with subsequent improvements, sediment and sand from the upper watershed and from the collapsing banks have accumulated behind the barrier. Large deposits of sand are evident along the floodplain, with thickly vegetated banks lining the stream. Abundant willows have colonized the sandy areas and banks, along with a diversity of high-seral vegetation such as *Carex nebrascensis* and *Carex utriculata*. This area was rated as PFC due to the stability that is ultimately enhanced by the elevational stabilizing effect of the 9 foot high barrier.

Photo above: The lower end of Reach C that is located just above the Templeton fish barrier.

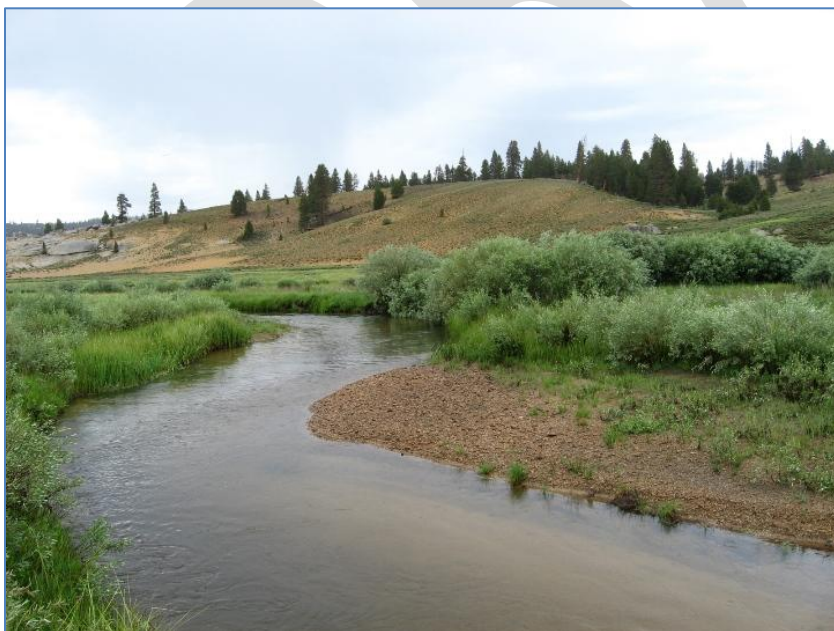
Photo above: The upper end of Reach C through Templeton Meadow with recent deposition within the floodplains.

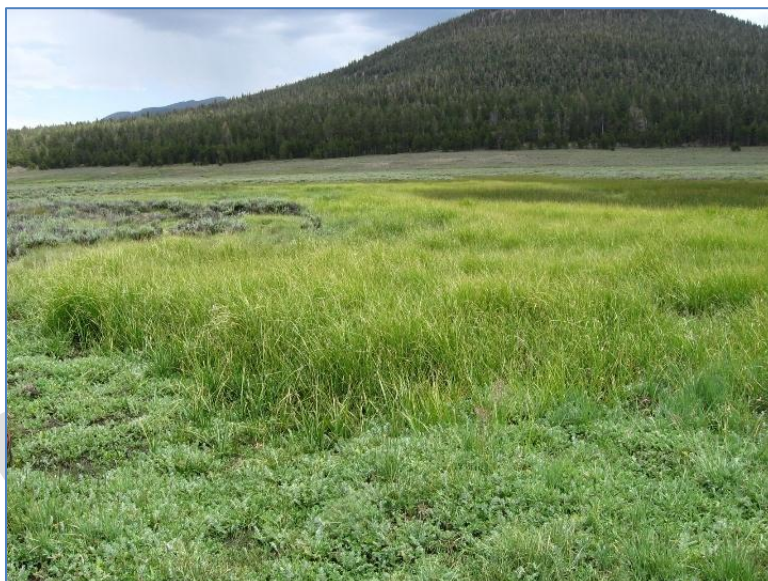
Photo above: Vigorous riparian vegetation which is characteristic of Movie Stringer meadow.

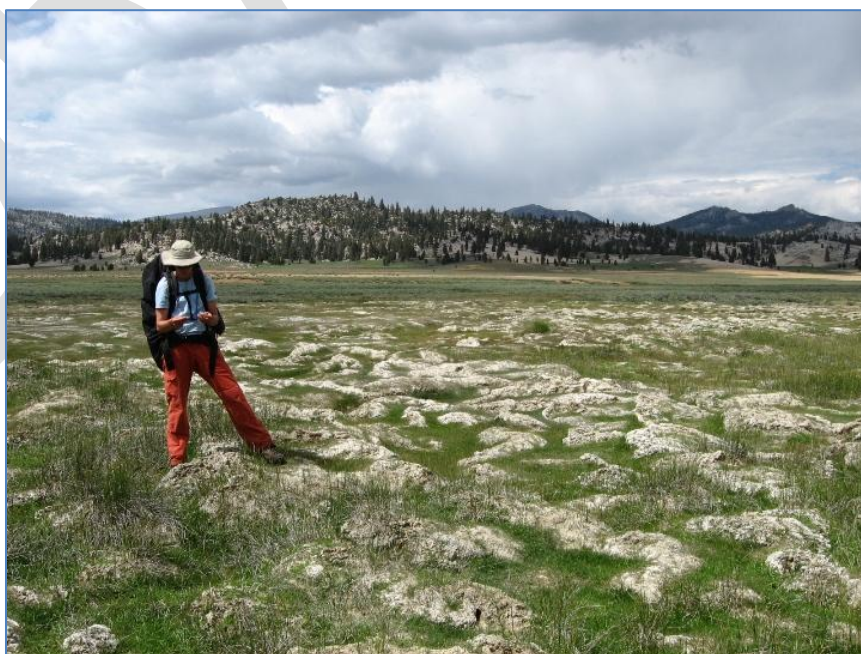
Photo above: A unique characteristic of Movie Stringer meadow, the alkali flat.

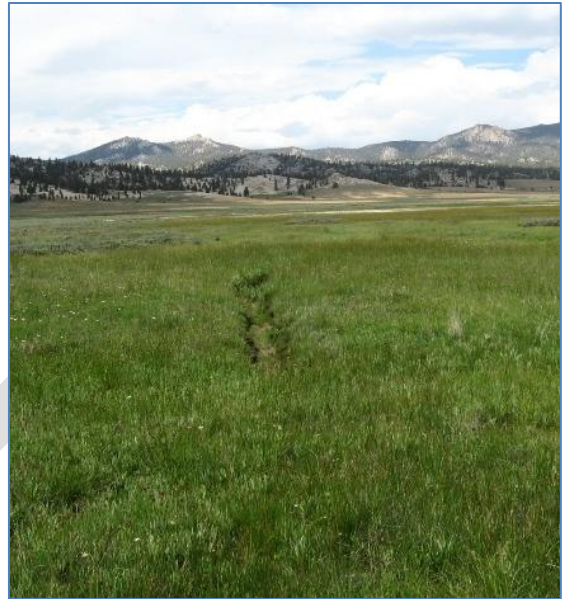
- **Rills/Gullies:** A few gullies were observed, but they were well vegetated and stable. There was one “raw” gully, but it occurred for only 50 feet, was in a flat location, and was well-vegetated at either end. This may be an old irrigation ditch that is recovering.

Photo above: Gully observed within Movie Stringer meadow which could be an old irrigation ditch.

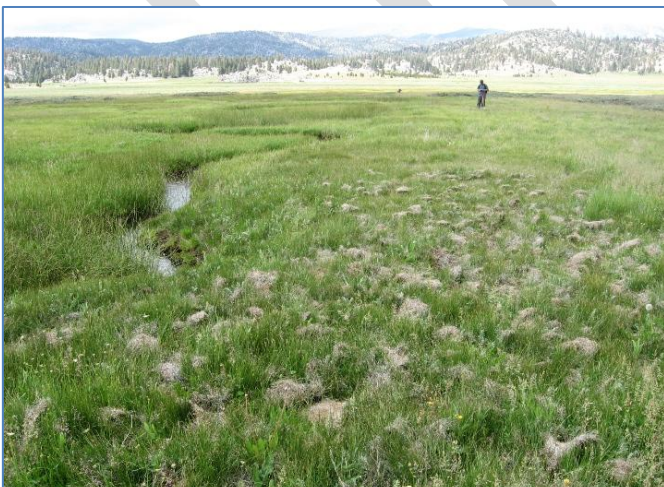
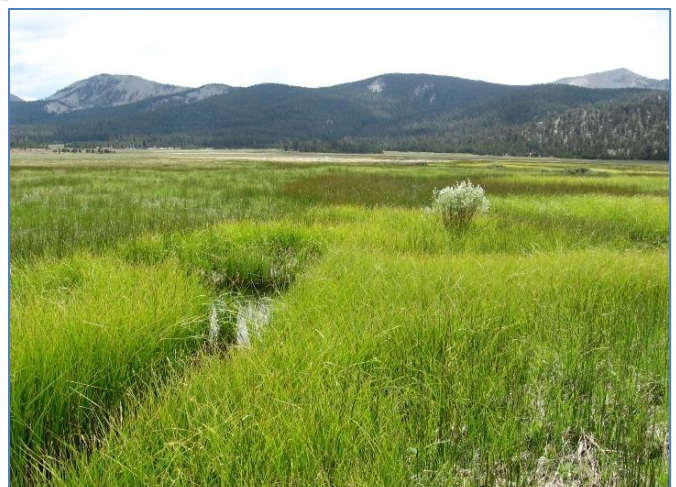
Photos above and below: Two locations within Movie Stringer meadow both exhibiting vigorous vegetation and *Carex* dominated communities.

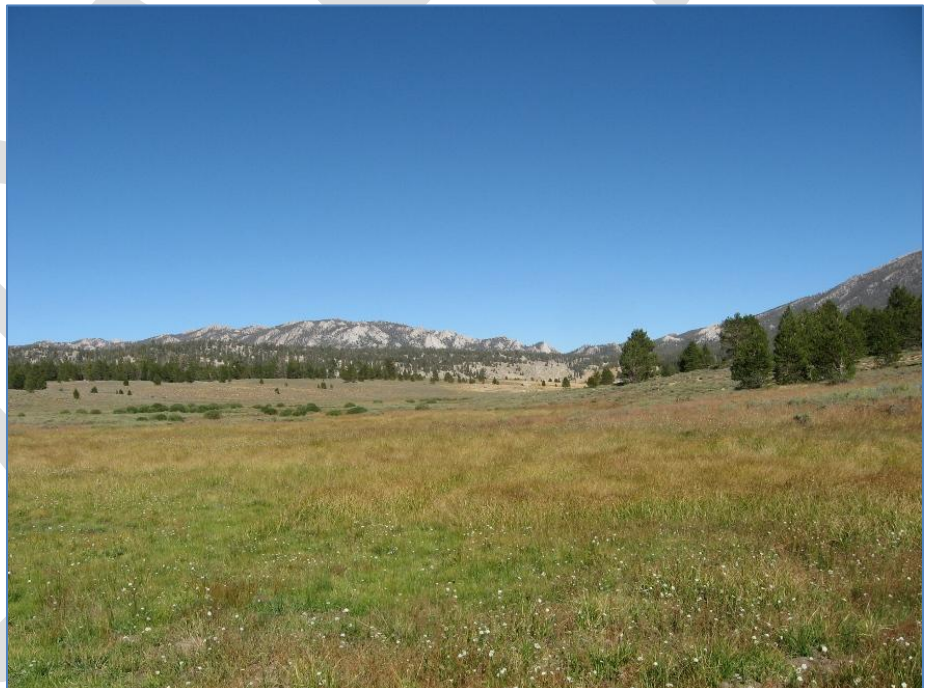
Photo above: View of the upland vegetation within Strawberry Meadow.

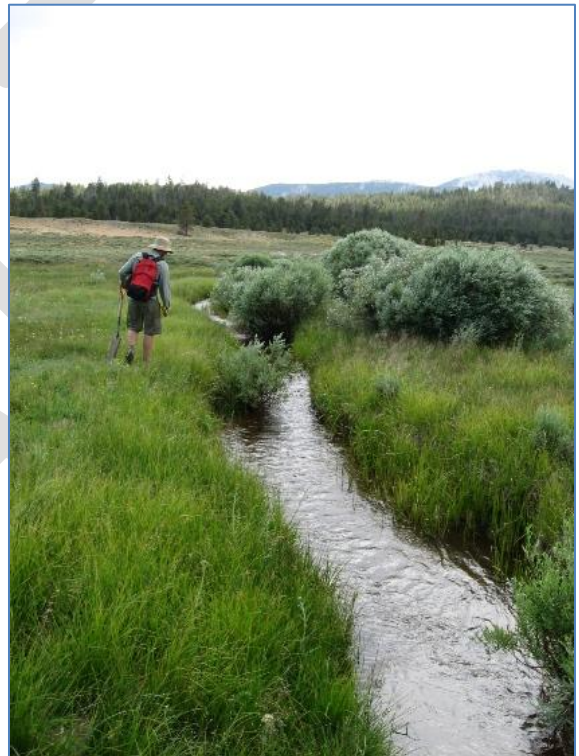
Photo above: Strawberry Creek in lower reach.

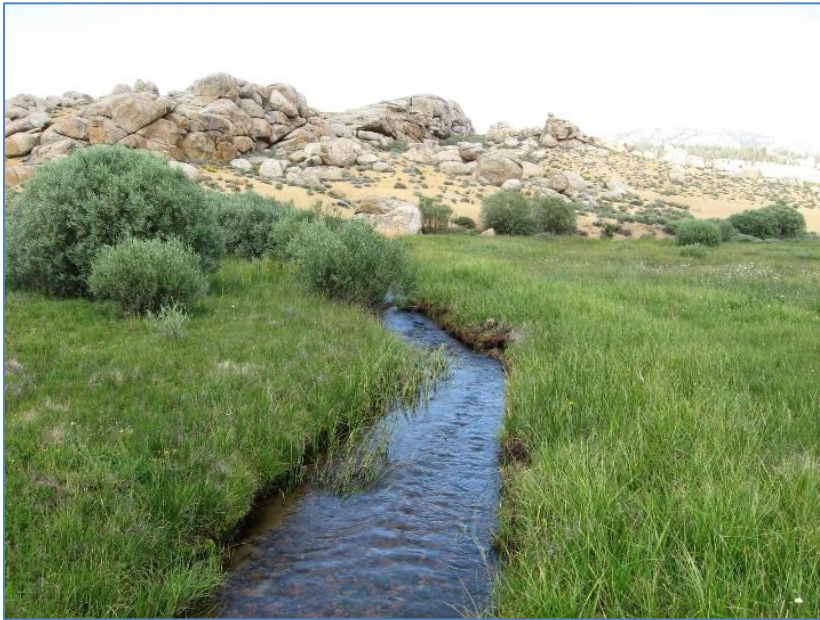
Photo above: Strawberry Creek in central section of meadow.

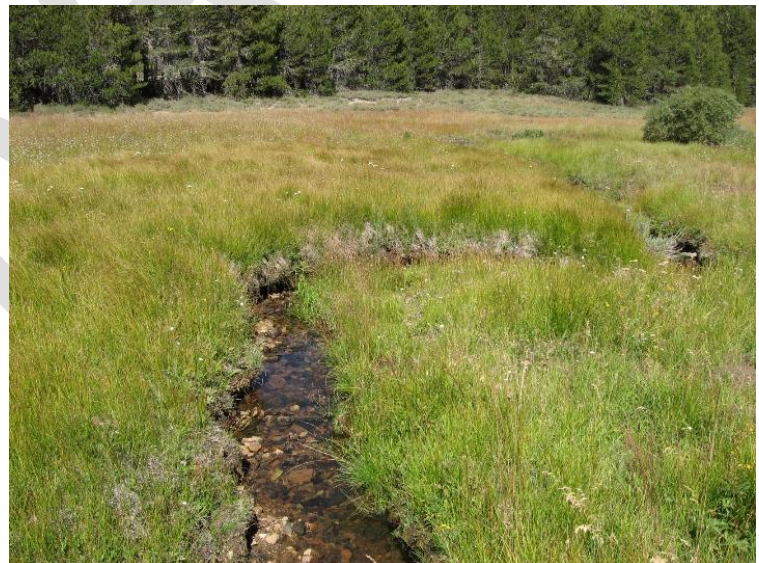
Photo below: Section of stream channel in the upper reach of Strawberry Meadow.

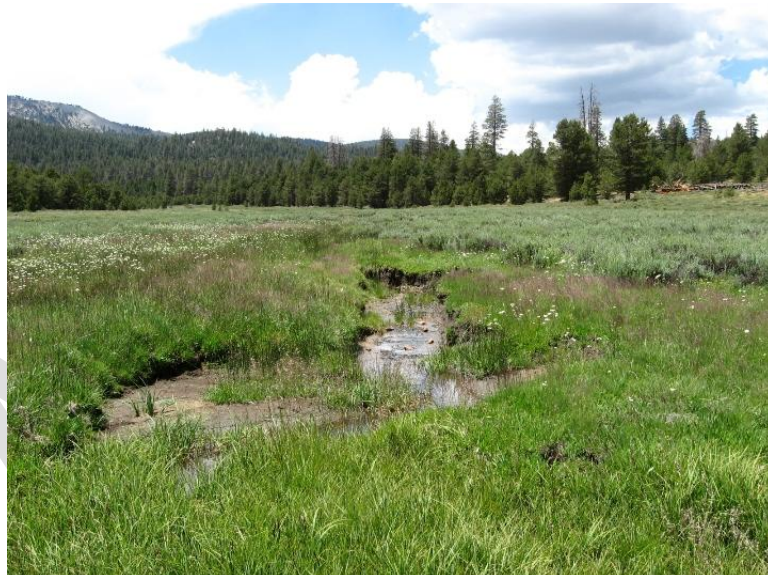
Photo above: Example of an active headcut within Schaeffer Meadow.

- **Headcuts:** There were a dozen or more active headcuts throughout the central part of the meadow. There was noticeable sagebrush movement into the former moist meadow at some locations. The channel appeared stable just below the headcuts, but

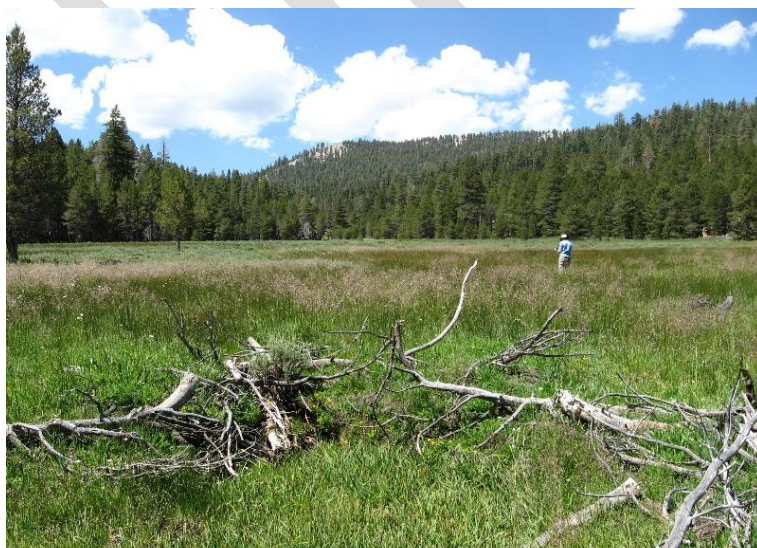
Photo above: Overview of the meadow area within Schaeffer Meadow.

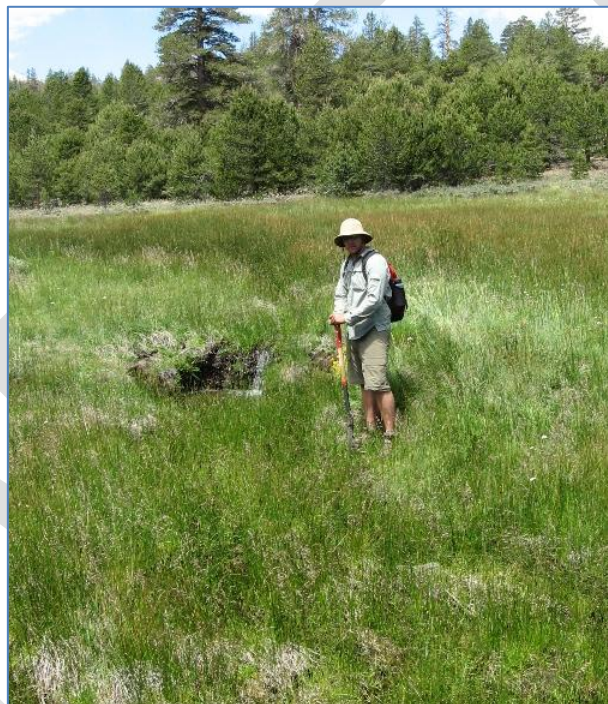
Photo above: Another example of headcuts within the meadow.

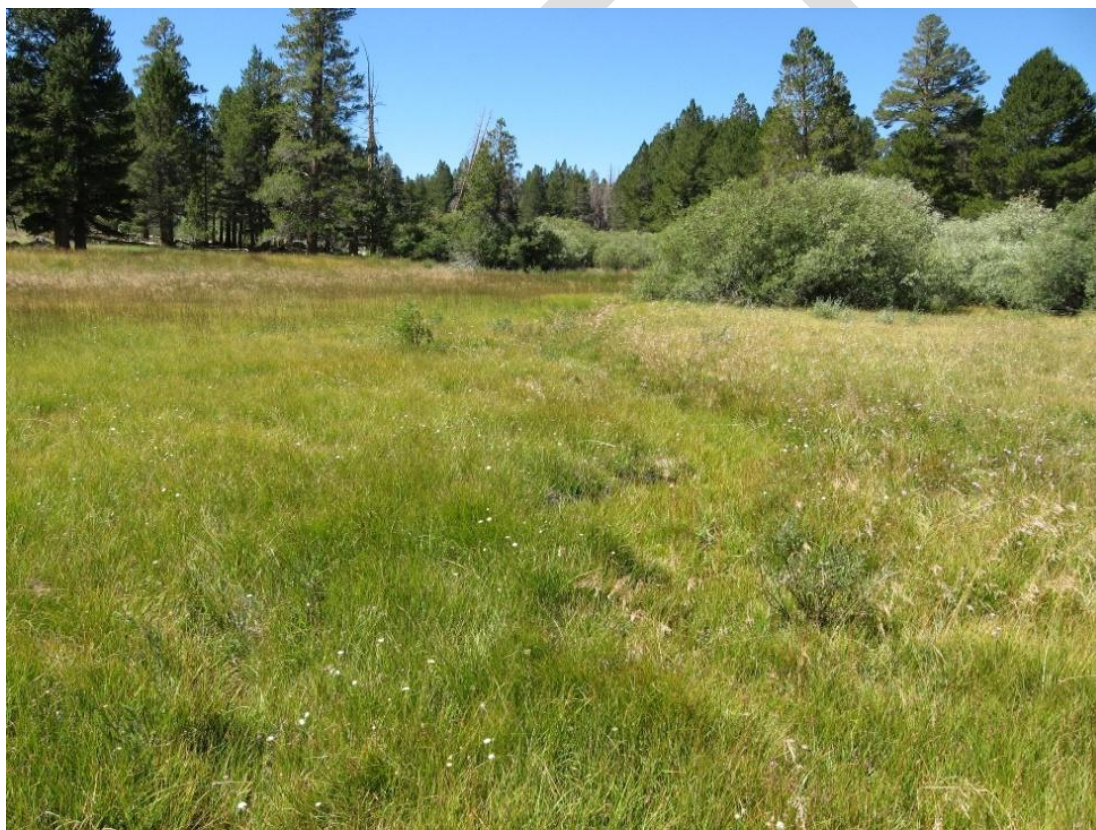
Photo above: Overview of Long Stringer Meadow, view of interface of wet meadow and moist meadow communities.

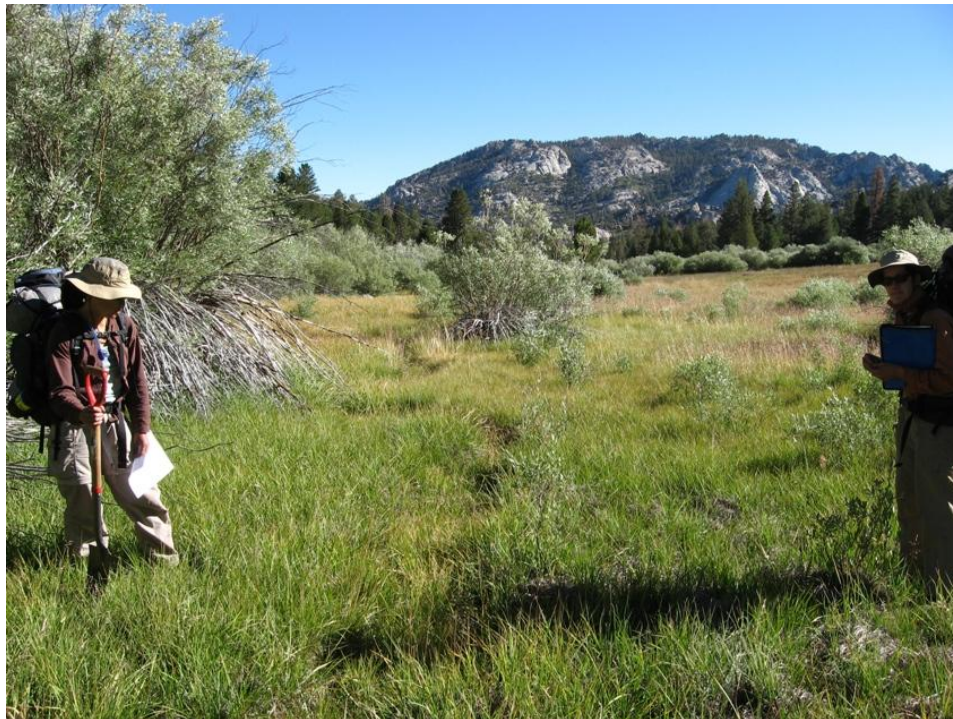
Photo above: A section of the discontinuous channel through Long Stringer meadow.

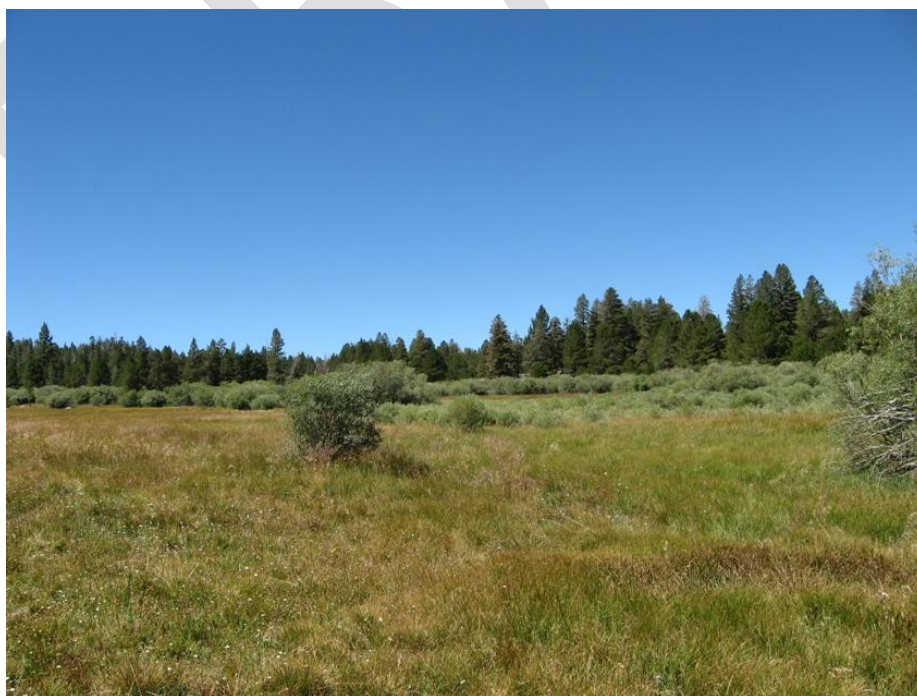
Photo above: Long Stringer showing abundant willow recruitment through the riparian area.

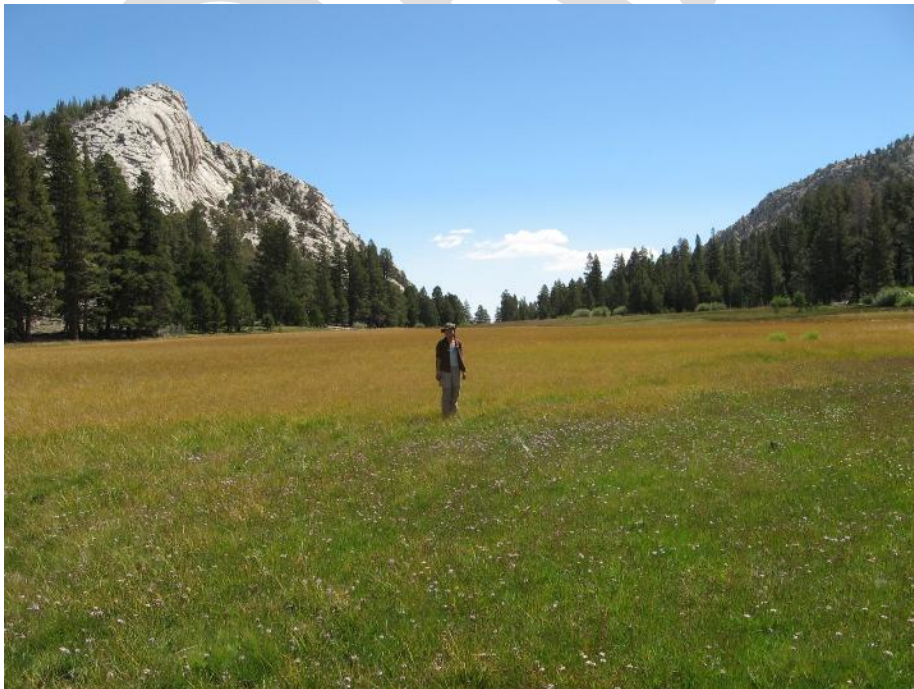
Left: Gomez Meadow: Noticeable vegetation demarcation zone where alluvium (dark green) soils intrude into the wetter meadow soils (golden area). The wet soils supported CAUT, where as the vegetation within the more recent alluvium intrusion is comprised of mid-seral species.

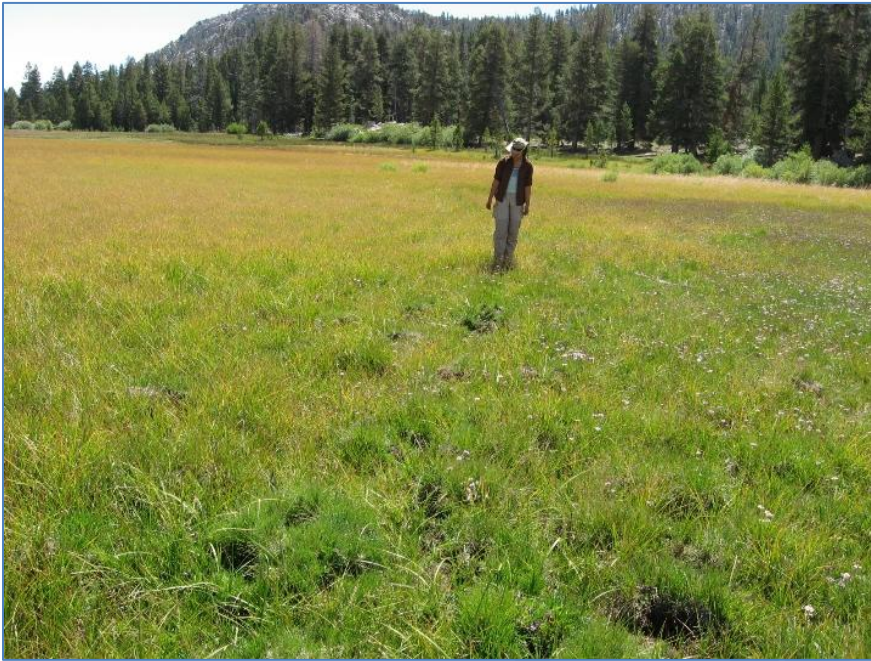
Photo above: Close-up of hummocked area around perimeter of Gomez meadow.

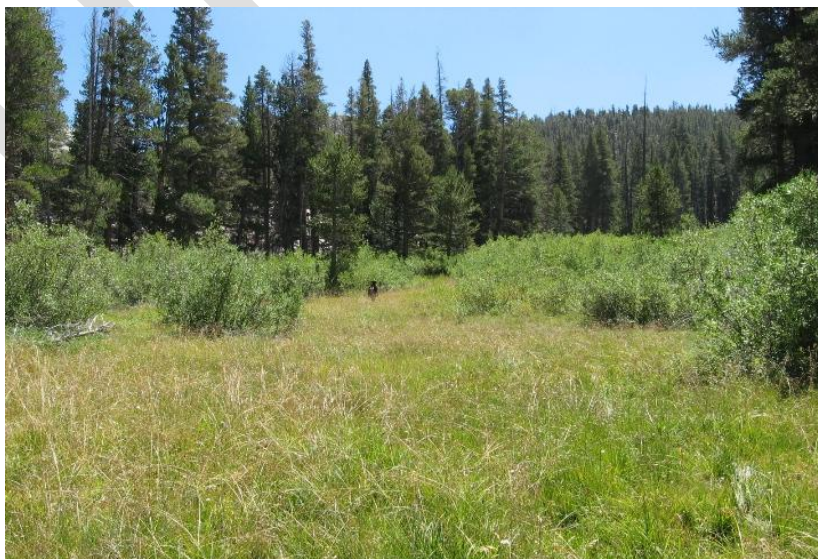
Photo above: Dry channel of Reach B of the Gomez Meadow complex.

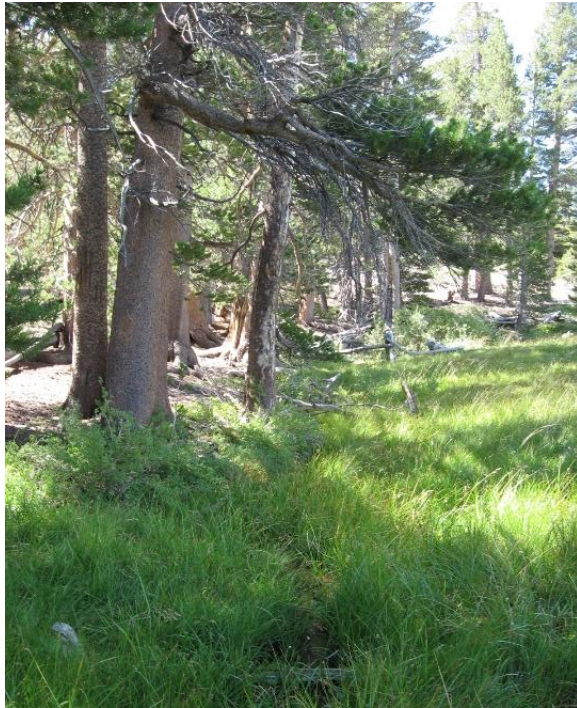
Photo above: The upper end of Reach D in Gomez Meadow.

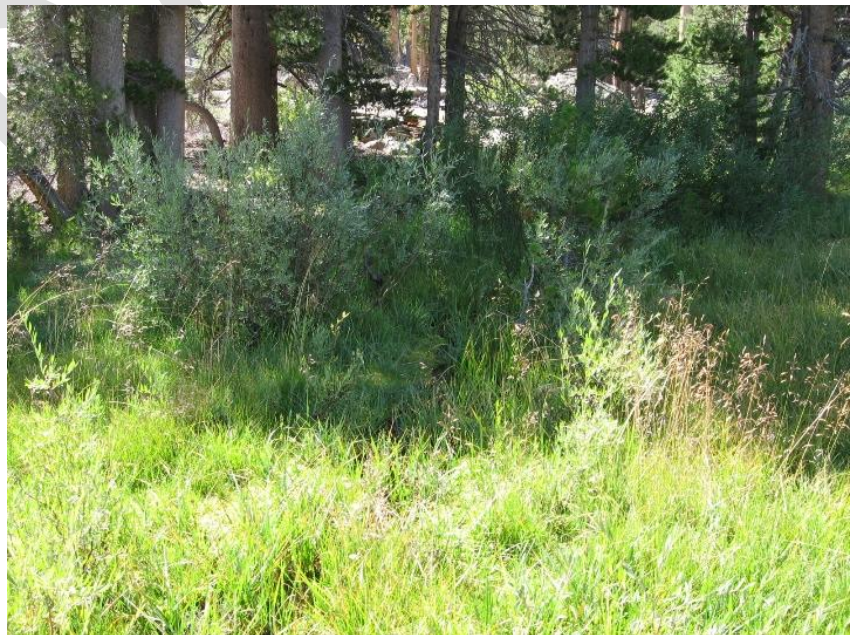
Photo above: Reach D in Gomez Meadow, showing stabilizing vegetation and willow recruitment along channel.
